RESEARCH ARTICLE

Geotechnical Analysis in the Case of Recovery Failure of West Out Pit Dump PT. Mifa Bersaudara

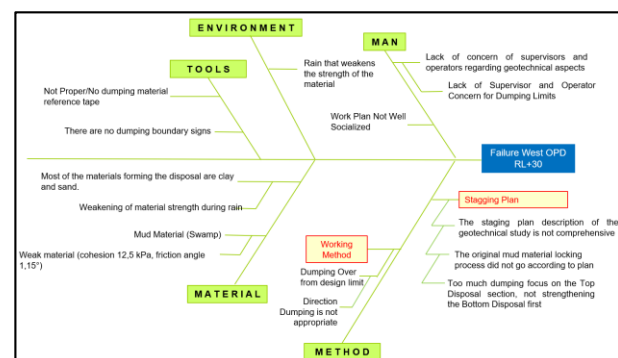
The case study that occurred at PT. Mifa Bersaudara, namely the Failure at the Out Pit Dump Elevation +30 on March 2, 2024, which resulted in damage to the planned Water Monitoring Point (WMP 24) compartment which is below the disposal at elevation +15. The historical base area of the dumping is a swamp area, which then became a slip plane due to the uncontrolled dumping of overburden material above it (Rezky and Zulkarnaen, 2023). Further explanation of the identification of the causes of failure is presented in the fishbone diagram (Fig. 1).

Fig 1. West Out Pit Dump fishbone analysis failure.

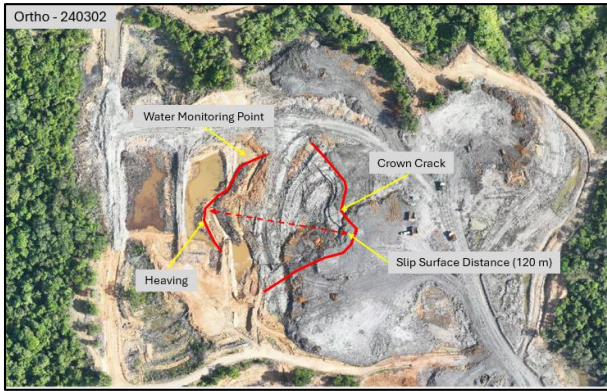
Crown crack at elevation+30 and Toe Failure (Heaving) at elevation+15 with a total failure distance from crown to toe of 120 m (Fig. 2).

Fig 2. West Out Pit Dump Failure Scheme Elevation+30

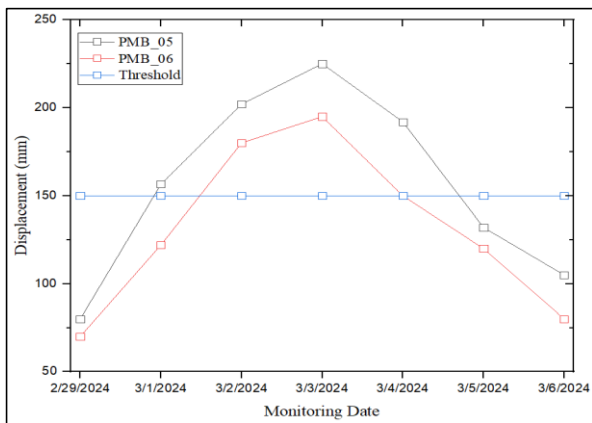
Monitoring tools at the disposal are also installed to determine the actual movement of the waste dump (Panpan et al, 2018; Singh et al, 2017) which is used as a reference to determine follow-up actions on disposal activities so as not to endanger operational activities (Mohamed, 2021). The results of monitoring in the failure area show a progressive pattern (landslide) as presented in (Fig. 3). This paper will further elaborate on emerging issues and challenges, action plans, recovery, and disposal development opportunities to meet annual disposal needs.

Fig 3. Report monitoring area failure

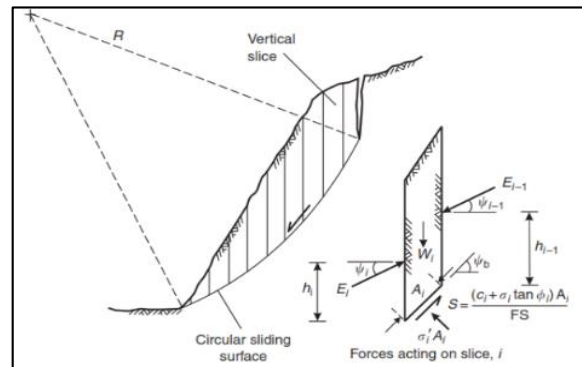
The West Out Pit Dump failure occurred due to uncontrolled dumping of mud material placement (Ali Ahmad et al, 2017; Ding et al, 2024; Sasaoka et al, 2015) at the base disposal with a thickness of 4-5 m based on the survey situation so that the load of the overburden pile at elevation+30 pushed the mud (weak material) and overburden material above it through and damaged the Water Monitoring Point (WMP 24) compartment. The imbalance of the restraining and driving forces caused the landslide, justifying the circular failure type in the residual material (Mukhopadhyay et al, 2017; Wyle and Mah, 2004). The failure forms a ring along the slip surface line. An illustration of the failure mechanism of West Out Pit Dump elevation +30 is presented in (Fig. 5).

Fig 5. Failure Mechanism (Wyle and Mah, 2004)

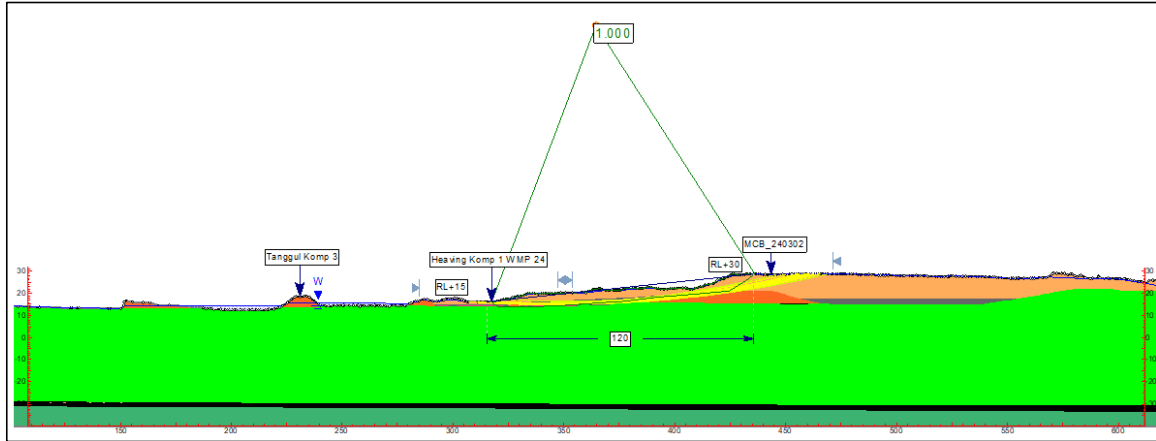
al, 2017; Nejan and Timothy, 2008) by correcting the existing model to match the actual conditions at the time of failure. The cross-section incision map and Back Analysis are presented in (Fig. 6 and 7).

Fig 7. Failure Analysis of West Out Pit Dump Back FK (Section A-A')

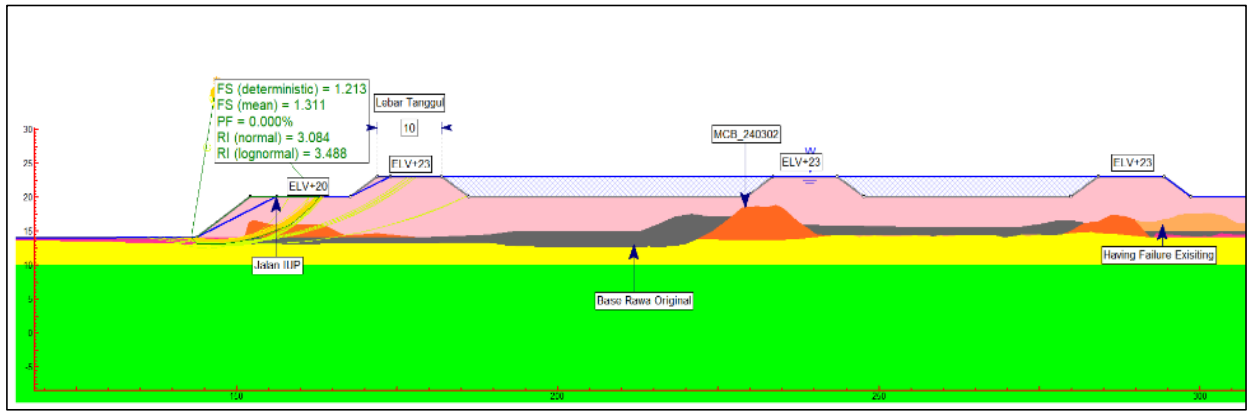
Fig 9. Geotechnical Analysis of Water Monitoring Point Reconstruction (WMP 24)

- Reconstruct compartment 2.3 by filling a flat pond at elevation +20, and forming a compartment embankment at elevation +23, the direction of discharge from west to east. Compartment 1 will be filled and will be a balance for the recovery of the West Out Pit Dump discharge.

- Moving 1 compartment to the north side, so that a total of 3 compartments with a planned storage volume according to regulations and the needs of the environmental team can be filled. The results of the analysis are presented in (Fig. 9).

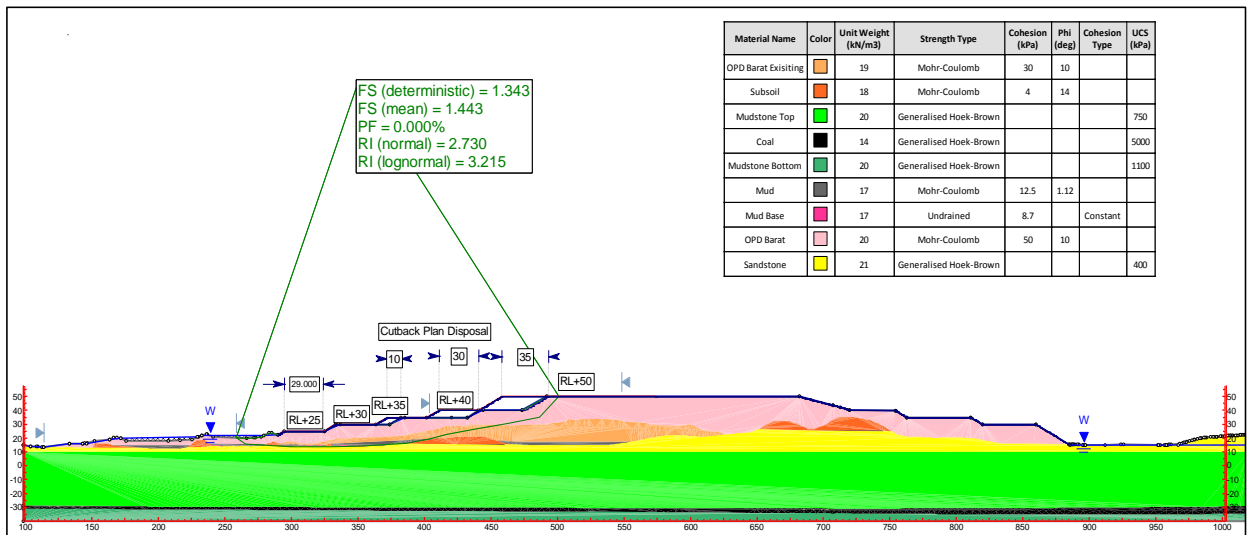
Fig 10. West Out Pit Dump Disposal Optimization Recommendation

The analysis results of Section A-A' states FK 1.34 and PF 0%, which means that the disposal is in a Safe condition with the following geometry changes.

After WMP 24 is completed in construction, the opportunity of West Out Pit Dump as a disposal site for OB material will be maximized in accordance with the geotechnical study based on the annual disposal plan design from the Mine Plan Team and design input parameters from the results of the Laboratory Test. The results of the analysis are presented in (Fig. 10).

- Cut back plan disposal elevation +50 (35 m)

- Cut back plan disposal elevation +40 (30 m)
- Cut back plan disposal elevation +35 (10 m)

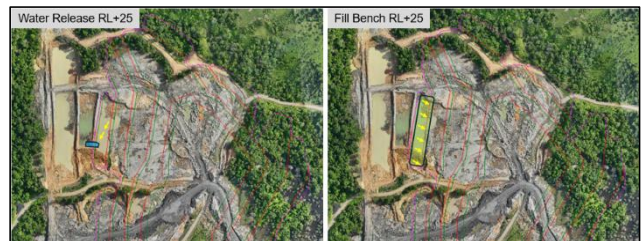
Fig 11. (a) Water Release Base elevation +25 (b) Fill Bench elevation +25

1. Release water at Base elevation +25 to WMP 24. Bench formation starts from the bottom bench of elevation +25 (both sides of WMP 24 and IUP Boundary Road) to strengthen the disposal foot and reduce the potential for heaving into compartment 1 and IUP Boundary Road. The formation was done gradually from the bottom. The dumping direction was from west to east (Fig. 11).

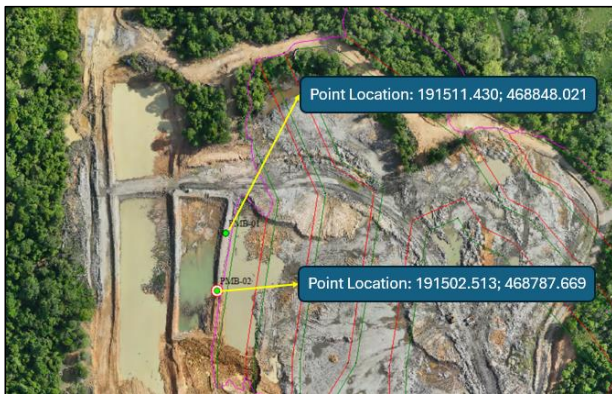
Fig 12. Prism Monitoring Installation

2. Prism monitoring in compartment 1 of WMP 24 will be installed to monitor the dumping progress. The geotechnical team will assess the location to see signs of

shifting compartment 1 during the dumping process (Fig. 12).

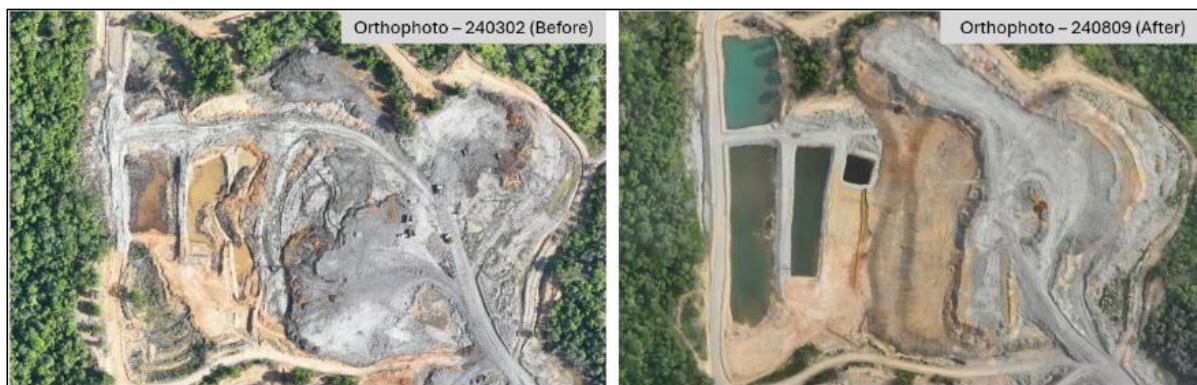
The implementation of the West Out Pit Dump elevation +30 recovery failure work in accordance with geotechnical recommendations has a positive impact, namely the Water Monitoring Point (WMP 24) for 3 compartments can be constructed according to the design along with the IUP ring road, and the addition of disposal capacity which was previously held at elevation +30, can then be optimized to elevation +50. So that the sequence of both stripping overburden and coal getting can run according to plan to achieve the company's annual target. Changes in the condition of the West Out Pit Dump before and after recovery are presented in (Fig. 13).

Fig 13. Orthophoto Recovery West Out Pit Dump

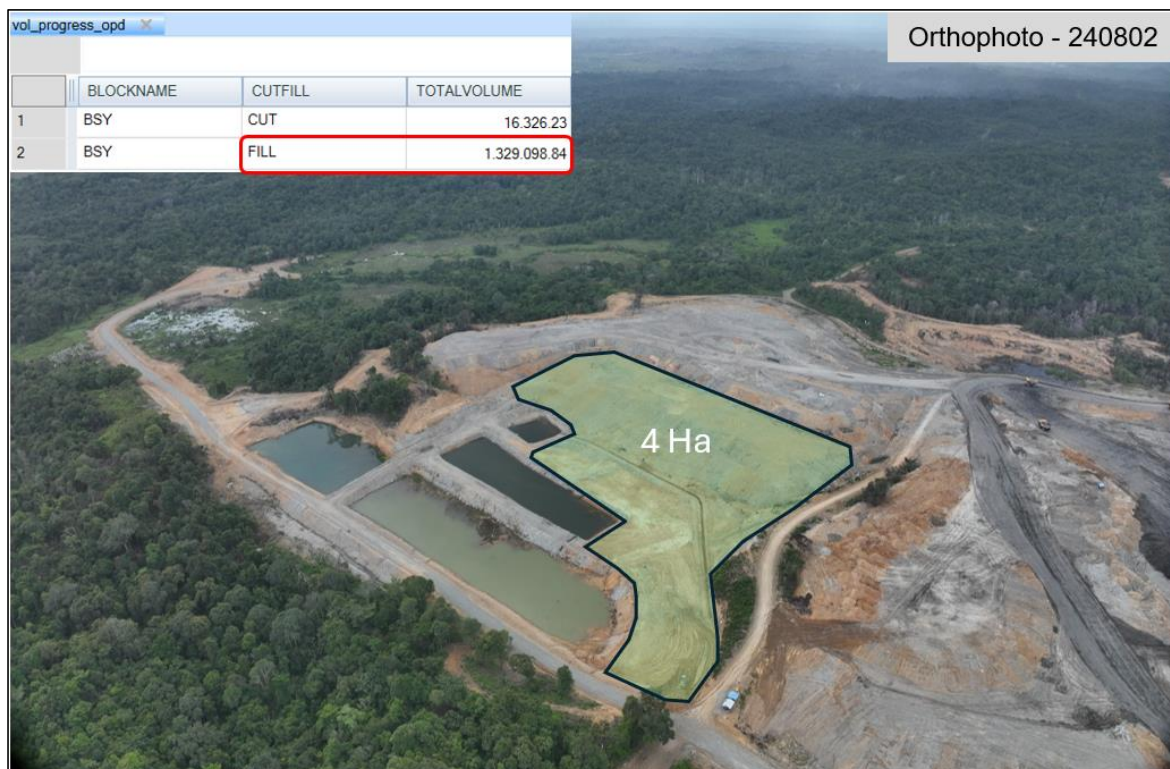
Work on the West Out Pit Dump Recovery according to the staging plan also has a positive effect on the addition of disposal capacity and additional reclamation areas, actual update of the situation in August 2024, there is a surplus of additional disposal progress volume in the ex-failure area of 1.3 million bcm which has a good impact on Overburden stripping and Coal Getting activities in the West Pit area. As well as an additional reclamation area of 4 Ha (Fig. 14).

Fig 14. West Out Pit Dump Optimization Results and Opportunity reclamation area

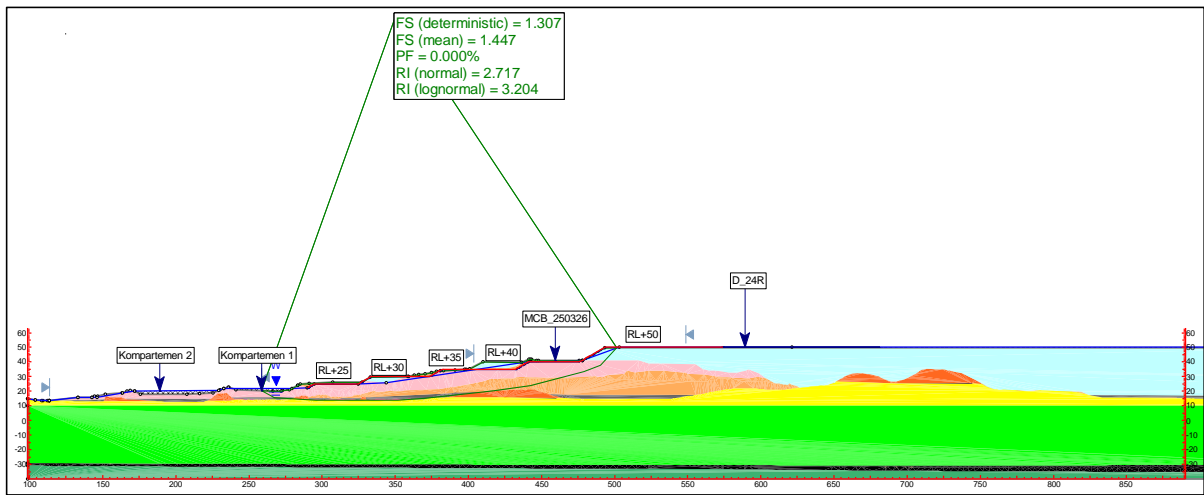
Fig 15. West Out Pit Dump Actual FK Update (August 2024)

Actual Safety Factors of the disposal development progress are analyzed to determine the suitability of recommendations with actual conditions in the field. Updates on the actual disposal slope stability with reference to the situation on March 26, 2025 are presented in (Fig. 15).

The results of the West Out Pit Dump slope stability analysis stated that the slope is in a Safe condition with FK 1.30, which means that the disposal is on track according to

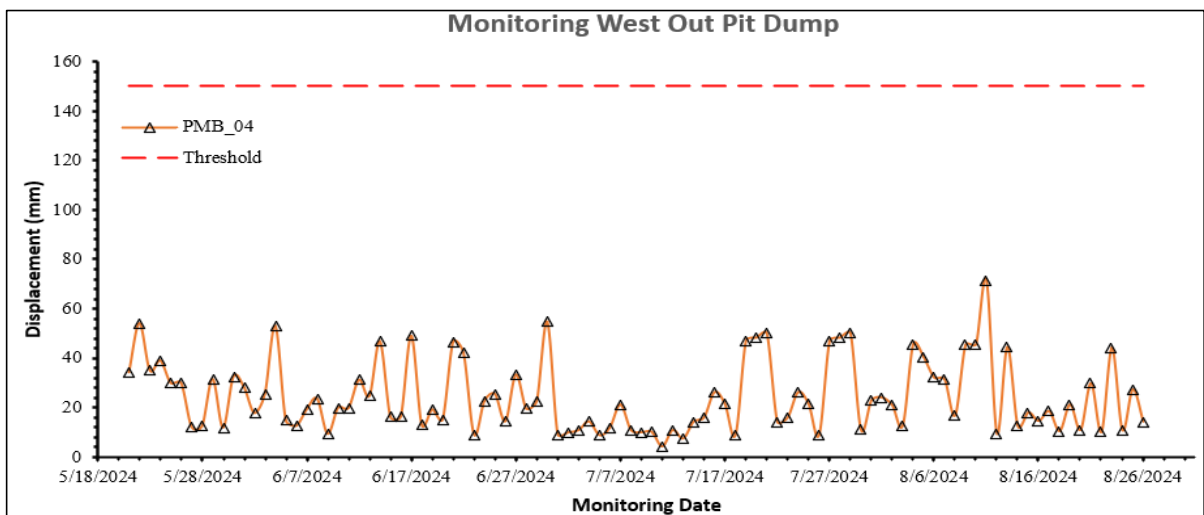
Fig 16. Report monitoring West Out Pit Dump

the planned elevation of +50. Progress monitoring of the West Out Pit Dump area is also presented in (Fig. 16) to find out the development of the disposal movement during the recovery progress. The results of prism monitoring stated that during the reconstruction, the resulting movement was still in the normal stage (Linear) with an average displacement of 50 mm. so it was concluded that both FK Progress and monitoring reports stated that the disposal slope was still safe. Changes in the Safety Factor during a failure, recommendations for geotechnical analysis, and actual recovery results are presented in (Fig. 17) to prove that the geotechnical analysis made is appropriate and can be implemented in the field.

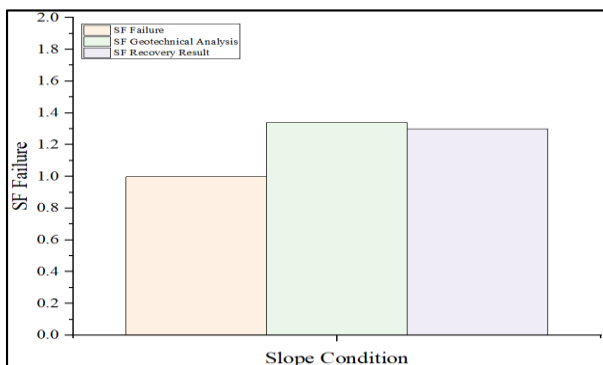
Fig 17. Safety Factors for various slope conditions

From (Fig. 17) it can be concluded that the recovery was successful, the slope is in a safe condition and in accordance with the results of the analysis made and is within the threshold value of the safety factor set, namely 1.3.
