# Analysis of the Effect of Vehicle Load on Road Layer Damage on Alluvial Bedrock Using PCI and ESAL Approaches: A Case Study of Air Molek–Taluk Kuantan Road, Riau Province, Indonesia

Bustanul Ulum<sup>1,\*</sup>, Elizar<sup>1</sup>, Mohammad Syahminan<sup>1</sup>

<sup>1</sup> Master of Civil Engineering, Programme of Post Graduate, Universitas Islam Riau, 28284, Indonesia.

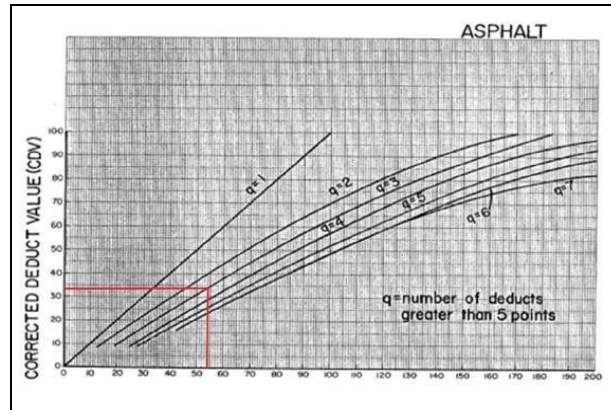
Fig 9. Graph Total deduct value (TDV) STA 1+100 up to STA 1+200

In the graph above, it can be seen that the corrected reduction value (CDV) at STA 1+100 to STA 1+200 is 33.

The PCI calculation on STA 1+100 to STA 1+200 is as follows:  $PCI = 100 - 33 = 67$  (GOOD) With the results of the calculation, the value of the condition of the road pavement studied can be determined whether it is in very good, good, or very bad condition by looking at the parameters of the PCI method. The following are the results of the PCI
