**VIBRATION ANALYSIS OF FIRE PUMP OF PEM
AKAMIGAS CEPU: A CASE STUDY**
(ANALISIS GETARAN PADA POMPA PEMADAM KEBAKARAN PEM
AKAMIGAS CEPU: STUDI KASUS)

Hernawan Novianto^{1*}, Sujono¹

¹Polytechnic of Energy and Mineral Akamigas

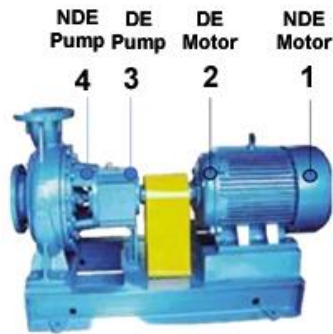
Figure 8. Vibration Measurement Scheme

C. Measurement Scheme
 Measurements were made at 4 points, namely the NDE motor, DE motor, DE pump, and NDE pump, and analysis was carried out on the axial, tangential and radial axes as shown in Figure 8. Measurements were made directly by attaching the transducer to the measurement points and vibration the tester will show the results of the analysis, both in the form of text and spectrum so that they can be analyzed to determine the right treatment.

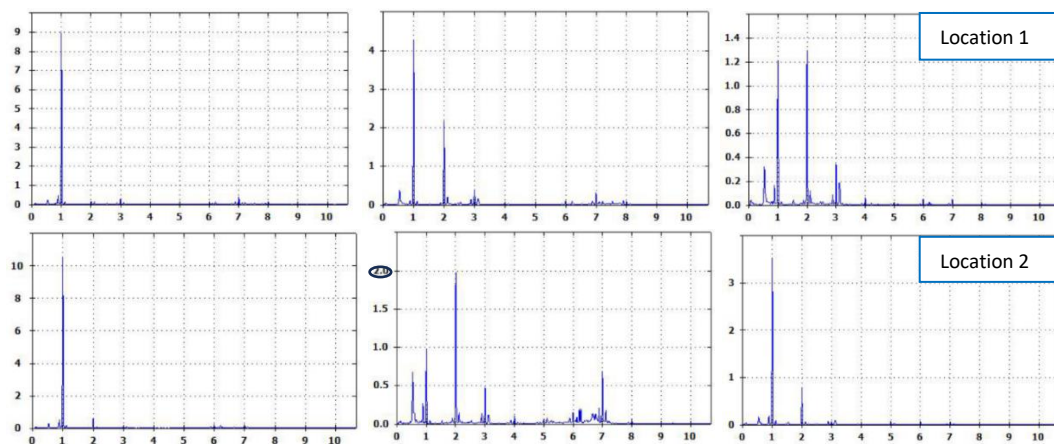
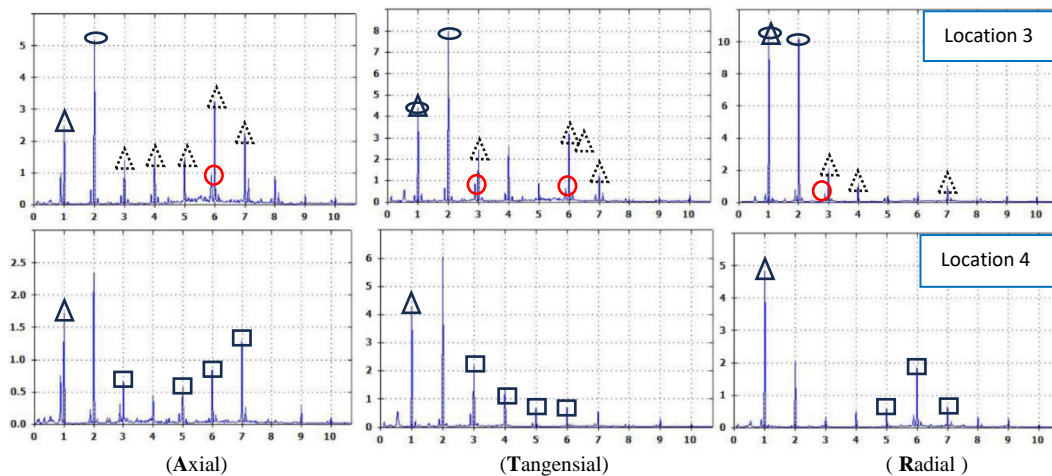
Figure 9. Vibration spectrum

Based on the characteristics of Vibration spectrum in Figure 9 (X Axis (Amplitude) unit : Orders and Y Axis (Frequency) unit : mm/sec) slack appears repeatedly at locations 3 and 4, the vibration amplitude at location 3 axis A (3A): 3.26 mm/s at order 6, 2.27/7.1.54/ 4, 1.48/5, 1.42/3. 3T: 3.22 mm/s at order 6, 2.58/4, 2.45/3,1.25/7 and 3R: 2.07mm/s at order 3, 1.09/4, 1.00 /7. indicates a mechanical looseness or bearing clearance problem (○). For locations 3A:0.92/order 5.88, 3T:0.89/order 2.88, 0.67/5.88 and 3R:0.51/order 2.88 indicating Pump Drive End Ball Bearing Wear (□). Peak vibration amplitude at 4A: 1.29 /order 7, 0.85/6 0.65/3.0.57/5. 4T: 2.17/order 3, 1.39/4, 0.72/6, 0.67/5 and 4R: 1.86/order 6, 0.65/7, 0.58/5. indicates a mechanical looseness or bearing clearance problem (□). Also the normal vibration amplitude (order 1) at locations 3 and 4 shows an imbalance, 3A: 2.45/1, 3T:4.41/1, and 3R:10.45/1, 4A:1, 73/1, 4T:4.26/1, and 4R:4.83/1. So that there is an indication of a pump imbalance (Δ). Whereas for 3R amplitudes: 10.45/order 1, 10.17/2, 3T:7.95/order

2, 4.41/1, and 3A:5.18/order 2, 2T:1.98/Order 2 indicate parallel misalignment (○).

1. The fire pump belonging to PEM Akamigas Cepu experiences Mechanical Looseness or Bearing Clearance Problems in alarm conditions, both at the Drive End and the Free End, especially at the Drive End which is in the red area, which if operated will cause damage
2. There are indications of serious parallel misalignment, where it is only recommended to operate for a short time
3. There is an indication of pump imbalance but it can still be operated for a long time.
4. There is minor damage to Pump Drive End Ball Bearing Wear

For this reason, it is recommended to immediately carry out maintenance / repairs or consult with experts regarding the indications resulting

from this study, and always monitor the increase in vibration that occurs.
