Slope Stability Analysis Using the Rock Structure Rating (RSR) Method And Atterberg Limit at Riau - West Sumatra Cross road Km 165 Harau Subdistrict, Lima puluh Kota Regency, West Sumatra Province

Keywords: Rock Structure Rating (RSR), Atterberg Limits, Slope Stability, Landslide

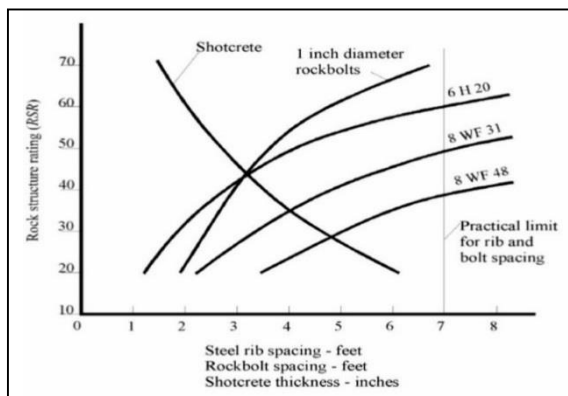
Fig 2. Diagram RSR (Wickham, 1972)

After obtaining the values of parameters A, B and C, then these values are added up to get the RSR value. The values obtained are then plotted on the RSR diagram, thus support can be identified (treatment) to be assigned to the slope.

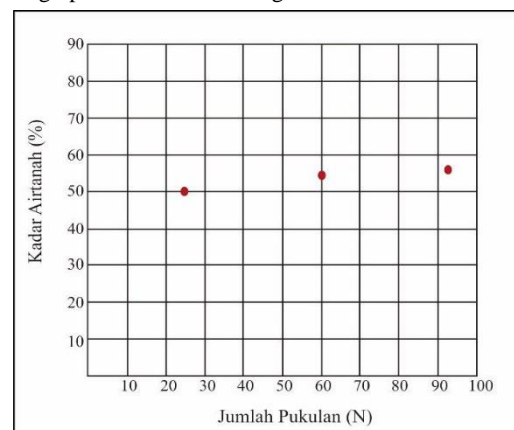
Figure 11. Test Graph *Liquid Limit* Soil Samples at the Bottom

On the test liquid limit Experiments were carried out 3 times with different water content. Experiment 1 was carried out with a slightly lower water content than the test results liquid limit its 58.86% takes 92 strokes. Experiment 2 was carried out with the water content being the result of the test liquid limit its 55.48% and takes 60 strokes. And experiment 3 was carried out with a lot of water content test results liquid limit its 50.71% takes 25 strokes. From the results of the three test trials, the liquid limit in the bottom soil sample produces a liquid limit value of 55.01%.

After obtaining the calculated value liquid limit, then the data on the number of blows and groundwater content is plotted onto the graph. Can be seen in Figure 12.

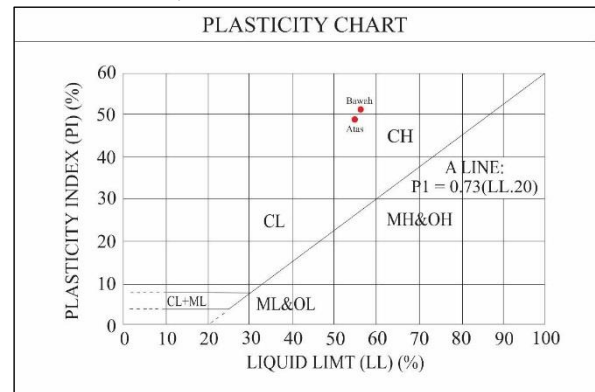
Fig 12. Graph *Plasticity Index* of Soil Samples

Then the results of calculating the plasticity index are plotted onto a graph (Figure 12), to find out the classification of the soil in the study area.

Based on the results of the Atterberg Limit analysis, soil samples were obtained from two parts of the lower and upper slopes, namely CH (Clay High Plasticity), an inorganic clay with high plasticity. From the sample analysis, it is known that clay with high plasticity can result in slope failure or landslides because clay is capable of absorbing/storing water but cannot allow water to pass through. With the condition of high water content, the strength of the soil is getting worse, which triggers landslides. The purpose of high plasticity soil is soil that has high swelling and shrinkage of the soil, thus if the range of water content in the soil is higher, the strength of the soil will be low or poor.

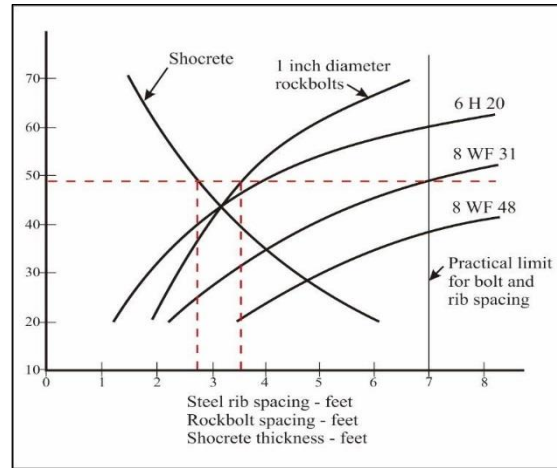
Figure 14. Slope RSR Graph Part 2

Parameter	Condition	Rating
A	Intensive folds or breaks	8
B	Close solid distance	19
C	No water, Condition medium solid	22
Total A + B + C		49
