RESEARCH ARTICLE

Slope Stability Analysis Using the Rock Structure Rating (RSR) Method And Atterberg Limit at Riau - West Sumatra Cross road Km 165 Harau Subdistrict, Lima puluh Kota Regency, West Sumatra Province

Keywords: Rock Structure Rating (RSR), Atterberg Limits, Slope Stability, Landslide

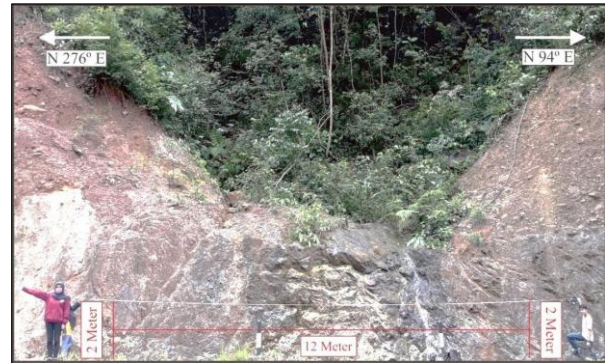
Fig 3. Measurement Location Scanline 1

Slope on scanline 1 has a slope length of 12 m and a slope height of 10 m. The lithology is in the form of sandstone on the bottom layer and conglomerate on the top layer. Sandstone with weathered brownish yellow color and fresh whitish yellow color, fine-medium grain size, rounded to moderate angles, good sorting, soft compactness can be crushed. Meanwhile, the conglomerate has a weathered color of yellowish brown and

fresh color of whitish brown, the size of the gravel fragments (1-20cm), the shape of the fragments is rounded, open packaging, the compactness is soft-a bit hard. On scanline it has experienced high weathering, because more than half of the rock has begun to decompose and has a significant discoloration. Discontinuity data on scanline 1 was in the form of joints/fractures, found 50 joints with the average distance between joints being close, the width of the discontinuity fracture being slightly narrow, and the water conditions being moist. In taking discontinuity data, only one layer area is at the retrieval distance scanline. Can be seen in Figure 3.

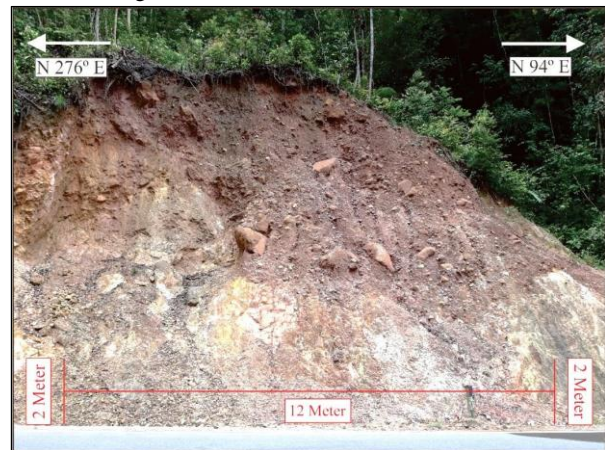
Fig 4. Measurement Location Scanline 2

Slope on scanline 2 has a slope length of 12 m with different slope heights, on the left the slope has a height of about 10 m, the middle is 5 m and the right is 8 m. The lithology is in the form of sandstone on the bottom layer and conglomerate on the top layer. Sandstone with brownish-yellow weathered color and blackish-gray fresh color, fine-medium grain size, rounded, well-sorted, hard compact. Meanwhile, conglomerate has a yellowish brown weathered color and whitish brown fresh color, the size of the fragments is cobble-stoned, the shape of the fragments is rounded, half-rounded, open packaging, hard compactness. On scanline 2 experienced mild weathering, because the rock experienced discoloration on the damaged aggregate or on the surface of the discontinuity plane. Discontinuity data on scanline 2 in the form of joints/fractures, found 70 joints with an average spacing between joints being moderate, the width of the discontinuity fracture being slightly narrow, and wet water conditions. In taking discontinuity data, only one layer area is at the retrieval distance scanline. Can be seen in Figure 4.

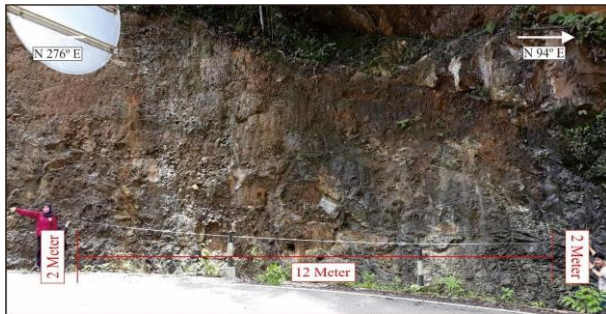
Fig 5. Measurement Location Scanline 3

Slope on scanline 3 has a slope length of 12 m and a slope height of 8 m. The lithology is in the form of sandstone on the bottom layer and conglomerate on the top layer. Sandstone with brownish-yellow weathered color and blackish-gray fresh color, fine-medium grain size, rounded, well-sorted, hard compact. Meanwhile, the conglomerate has a weathered color of yellowish brown and fresh color of whitish brown, the size of the gravel-barky fragments, the shape of the fragments is rounded, open packaging, the compactness is rather loud. On scanline 3 experienced light weathering. Discontinuity data on scanline 3 in the form of joints/fractures, found 80 joints with an average spacing between joints being moderate, the width of the discontinuity fracture being slightly narrow, and wet water conditions. In taking discontinuity data, only one layer area is at the retrieval distance scanline. Can be seen in Figure 5.

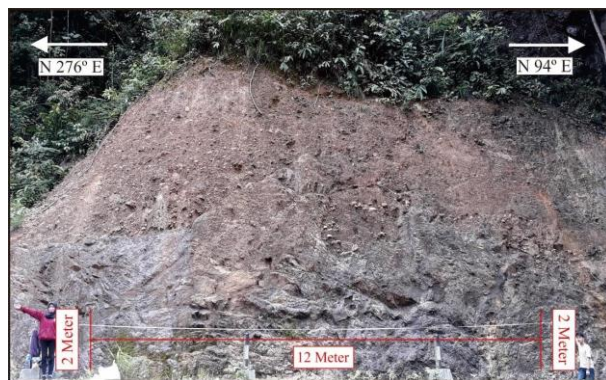
Fig 6. Measurement Location Scanline 4

Slope on scanline 4 has a slope length of 12 m and a slope height of 8 m. The lithology is in the form of sandstone on the bottom layer and conglomerate on the top layer. Sandstone with brownish-yellow weathered color and blackish-gray fresh color, fine-medium grain size, rounded, well-sorted, hard compact. Meanwhile, the conglomerate has a weathered color of yellowish brown and fresh color of whitish brown, the size of the gravel-barky fragments, the shape of the fragments is rounded, open packaging, the compactness is rather loud. Discontinuity data on scanline 4 in the form of joints/fractures, found 70 joints with the average distance between joints being close, the width of the discontinuity fracture being slightly narrow and the water conditions being moist. Scanline 3 experiences mild weathering, because the rock changes color on the damaged aggregate or discontinuity surface. In taking discontinuity data, only one layer area is at the retrieval distance scanline. Can be seen in Figure 6.

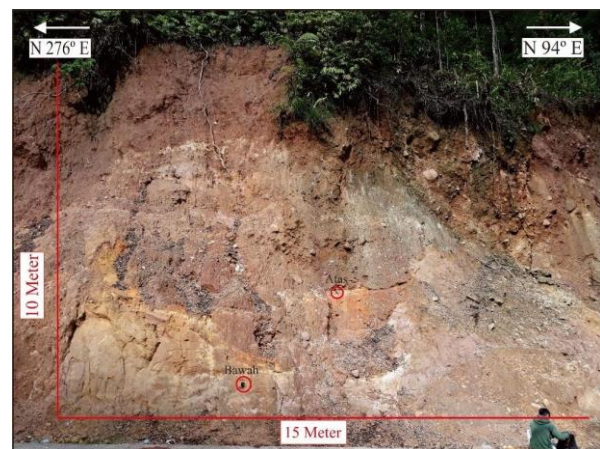
Fig 9. Soil Sampling Research Slope

Research slopes that experience high weathering thus some of the rock material has become soil is used as a sample used to carry out sieve analysis (sieve analysis). The research slope is

15 meters long and 10 meters high. The soil sample used for sieve analysis was divided into two parts, namely the upper and lower parts. Can be seen in Figure 9.

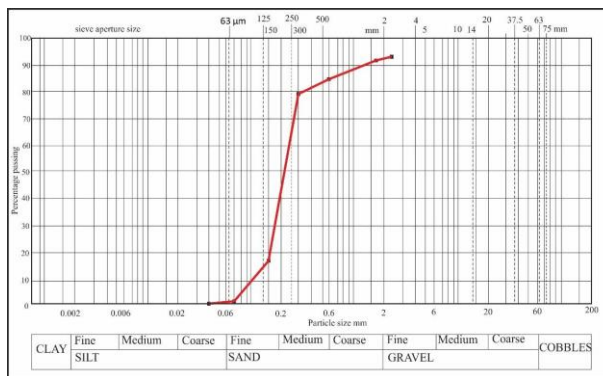
Fig 10. Graph of Soil Sample Sieve Analysis at the Bottom

After obtaining the values from the sieve analysis results in Table 7, then these values are plotted into the sieve analysis diagram Figure 10 to determine the grain distribution of the soil sample. The values plotted into the sieve analysis diagram are the % Finer values and the sieve size.

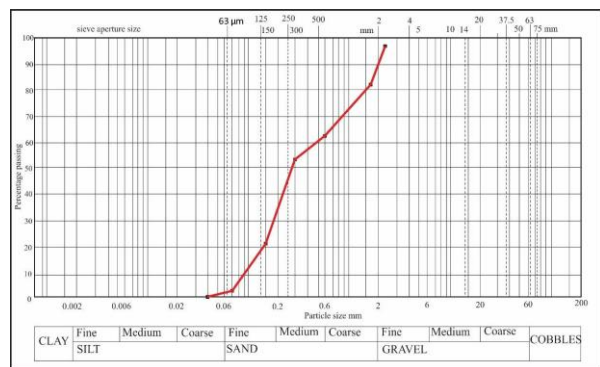
Fig 11. Graph of Soil Sample Sieve Analysis at the Top

From the calculation results it was found that the bottom soil sample had uniform grain uniformity with poor gradation and moderate sorting, medium grain size and little gravel. Whereas at the top it has uniform grain uniformity with poor

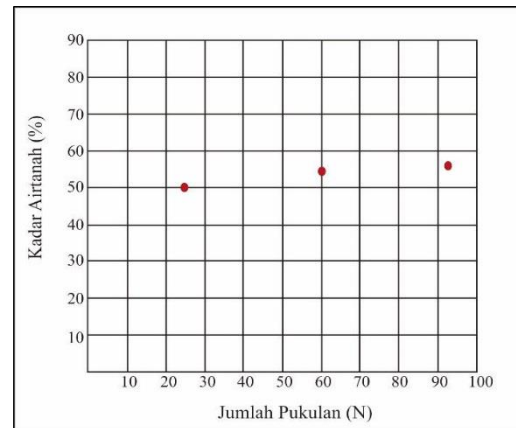
Figure 11. Test Graph *Liquid Limit* Soil Samples at the Bottom

On the test liquid limit Experiments were carried out 3 times with different water content. Experiment 1 was carried out with a slightly lower water content than the test results liquid limit its 58.86% takes 92 strokes. Experiment 2 was carried out with the water content being the result of the test liquid limit its 55.48% and takes 60 strokes. And experiment 3 was carried out with a lot of water content test results liquid limit its 50.71% takes 25 strokes. From the results of the three test trials, the liquid limit in the bottom soil sample produces a liquid limit value of 55.01%.

After obtaining the calculated value liquid limit, then the data on the number of blows and groundwater content is plotted onto the graph. Can be seen in Figure 12.

The conclusion from the liquid limit test of 2 soil samples obtained different values. The lower slope has a value of 38.8% and the upper slope has a value of 15.01%. From the results of the analysis, it is because the different water content causes each experiment to have a different number of strokes, the less water content in the sample, the greater the number of strokes. Meanwhile, the more water content in the sample, the less the number of blows.

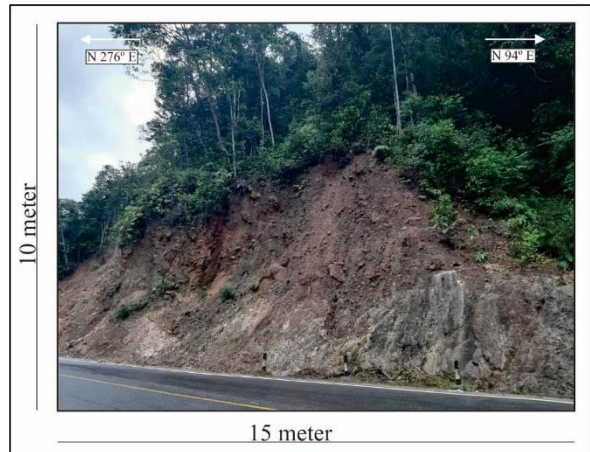
Fig 13. RSR Research Slope Part 1

The slope of part 1 in the analysis of the RSR method has a slope length of 15 meters and a slope height of 10 meters. Has a high level of weathering with sandstone and conglomerate lithology. In parameter A, it is known that the type of rock is weathered sediment with type 4 and there is a geological structure in this study, namely intensive folding or fracture with a rating of 6 (Table 2).

dip known from direct field observations, then the slope face on the slope has a value of 75° which is included in the vertical table, the distance between joints is very close < 2 in, this is known from the measurement of the distance between joints using measuring tools in the field with a rating of 13. Can be seen in Table 3. Then in parameter C by looking at the water conditions on the research slope, where the research slope in section 1 is included in the no water category and the joint conditions are in the moderate category with a rating of 18. Can be seen in Table 4.

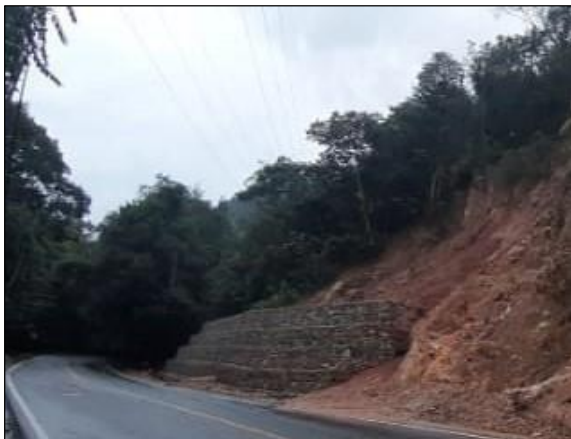
Fig 22. Landslide Mitigation with Retaining Rock Embankments

The condition of the research slope on the left side of the slope has experienced landslides. In the landslide section, it can be seen that the rocks on the inside of the slope have experienced weathering and tend to move toward the soil. Mitigation that can be given to the slopes that have experienced landslides is different from the rock slope conditions studied. One example of mitigation given to slopes that have experienced landslides is the construction of rock embankments to resist landslides. Can be seen in Figure 22.
