RESEARCH ARTICLE

## A Review of Critical Land in Areas Dominated by Volcanic Deposits to Support Local Ecosystem Rehabilitation Planning

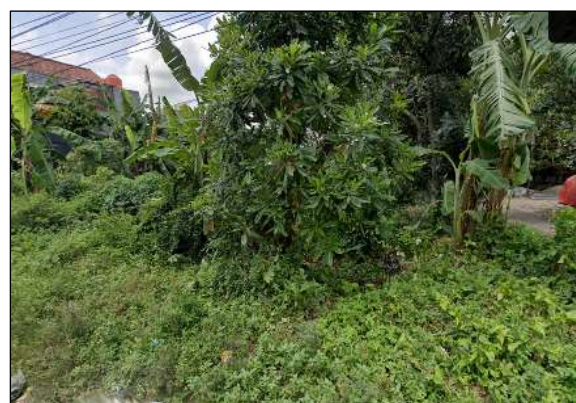
Fig. 6. Non-critical land condition in RW 13 Kedunghalang garden

The criticality level of the land has a value of 20, which is included in the non-critical category. The land cover is in the form of rice fields, but is covered by vegetation. The dominant vegetation is perennial and bamboo. The slope

class of the non-critical land is flat. The erosion rate is very low. An example of non-critical land is shown in Figure 6.
