# Improving Slum Infrastructure in Sri Meranti Village Pekanbaru City

**Abstract.** Sri Meranti Village is one of the villages in Rumbai District, Pekanbaru City, which still has slum status. Many factors can influence the existence of slum areas. These factors include urbanization, infrastructure, economics, urban land, spatial planning, socio-cultural urban attractiveness, building ownership status, and length of residence. Sri Meranti Village was included in the Pekanbaru City Slum Decree in 2017. Problems faced by the community include poor residential conditions, substandard road networks, the lack of clean water, which relies on communal wells, poorly maintained drainage systems, the absence of waste management facilities, the continued lack of proper drainage and the lack of hydrants in the area. The purpose of this study was to identify infrastructure improvements in slum areas. The research method used was a qualitative descriptive method with field observations, interviews with RT RW and local residents. The results indicate the need for infrastructure improvements, such as repairing and paving neighborhood roads, improving drainage, installing trash bins, improving comm

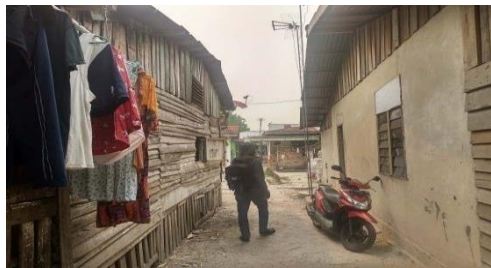
The coverage of neighborhood road services can be seen from two indicators: the need for connectivity between housing units within a regional settlement and the need for connectivity between roads within housing units within a regional area. A field survey revealed that within the slum areas of Sri Meranti Village, there are 130 meters of neighborhood roads not served by the neighborhood road network.

**Figure 1.** Condition of environmental road service coverage

Road damage is indicated by changes in the shape of the road surface [4]. The plan to improve the quality of road infrastructure depends on the condition of the existing road network. For unpaved roads, road quality improvement is achieved through paving/casting (cementing). For damaged pavement, road repairs can be carried out in the form of pavement overlays. In the Sri Meranti Urban Village slum area, the maximum width of road management is 2.5 meters and the minimum width is 1.5 meters.

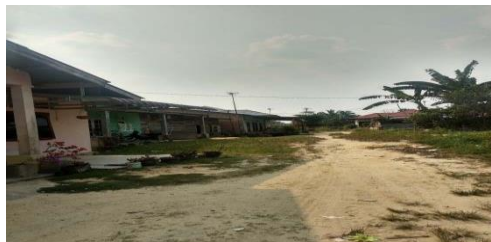
The quality of neighborhood road surfaces is the condition of the existing neighborhood road pavement types in Sri Meranti Village. Based on the results of observations, the quality of neighborhood roads in Sri Meranti Village is cemented, but there are still neighborhood roads with unpaved dirt surfaces. The neighborhood road surface with cemented and dirt pavement types is damaged, with a length of 1,185 meters.

**Figure 2.** Environmental road surface quality condition

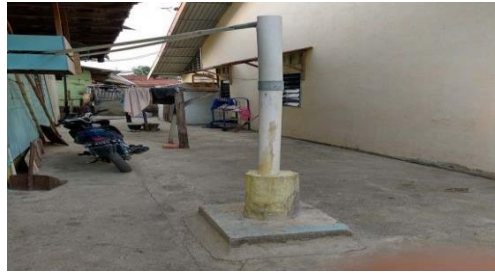
Access to safe drinking water is defined as the community's access to a drinking water distribution network that meets drinking water health standards, which include physical, microbiological, and chemical requirements. Observations at the study site revealed that the availability of safe drinking water is suboptimal because not all residents have access to safe drinking water. This is because the water quality does not meet health standards, with 110 households experiencing odor, color, and cloudiness. However, the majority of residents have access to safe drinking water.

**Figure 3.** Drinking water source

Generally, residents in the study area use drilled wells as their source of clean water for bathing and washing. For drinking water, some residents purchase gallons of water, while others boil water from drilled wells. Currently, there is one communal clean water source in the planning area that can be shared, although it does not yet meet the drinking water needs of the study site.

In general, there are no serious problems with clean water infrastructure in the slum areas of Sri Meranti Village. Residents use drilled wells collectively or individually to obtain clean water, and several neighborhood units (RTs) already have communal clean water. The proposed provision of communal clean water and sanitation facilities in the slum areas of Sri Meranti Village can be directed at public facility locations. Therefore, consideration should be given to the provision of collective clean water tanks, which are also integrated with collective public toilets at these locations.

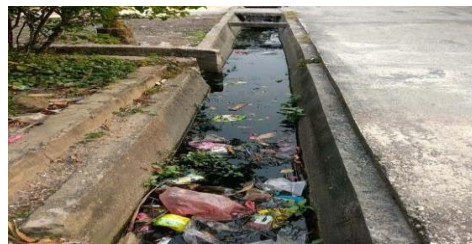
Environmental drainage that is unable to drain rainwater runoff will cause flooding. Observations show that many drainage channels in the Sri Meranti Village area are poorly maintained. The existing drainage channels are unable to fully drain runoff due to blockages caused by narrowing of the channels, accumulation of garbage, stagnant water flow, and sedimentation. This results in an area affected by flooding of 0.93 hectares.

**Figure 4.** Drainage incapable of draining water runoff

Drainage is a curve or water channel on the surface or underground, either naturally formed or man-made. [5] The plan to improve the quality of environmental drainage infrastructure will involve the construction of drainage on both the right and left sides of roads, as several roads in the slum areas of Sri Meranti Village still lack drainage. The planned drainage width is between 0.4 and 1 meter.

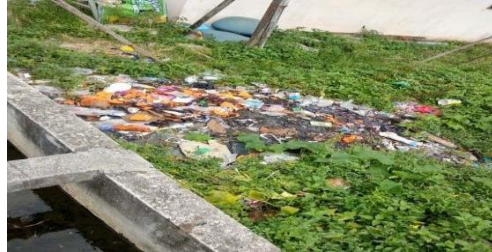
Based on field observations, the condition of waste infrastructure and facilities at the study site does not meet technical requirements. There are no waste bins with waste sorting at the domestic or household level, only one TPS available in the study area, no 3R (Reduce, Reuse, Recycle) TPS, only a garbage truck at the neighborhood level, and no integrated waste processing facilities (TPST) at the study site. The total number of households with facilities and infrastructure that do not meet technical standards, namely the lack of waste bins with waste sorting at the domestic or household level, is 298 households.

**Figure 5.** Waste condition

The waste management concept is implemented at two scales: Individual-scale management, which involves processing directly at the source (households/offices) by waste producers. In addition to the waste infrastructure mentioned above, consideration should also be given to providing waste management infrastructure at the Waste Management Site (TPST), which is a waste disposal site (TPS) integrated with integrated waste processing, such as large-scale composting.
