RESEARCH ARTICLE

Geotechnical Analysis in the Case of Recovery Failure of West Out Pit Dump PT. Mifa Bersaudara

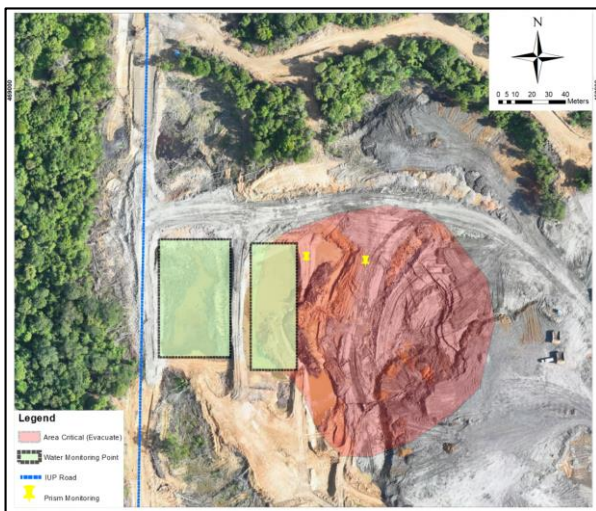
Fig 4. Research Location (West Out Pit Dump)

The research location is in West Out Pit Dump elevation +30 which is the original swamp area, at this location there are 3 projects that will be implemented, namely the construction of the iup boundary road, Water Monitoring Point (WMP 24), and the development of the disposal presented in (Fig. 4).

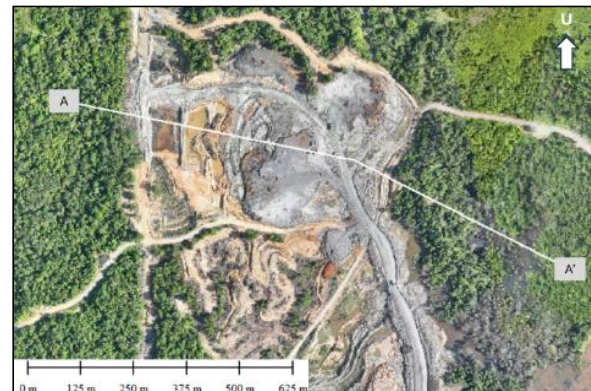
Fig 6. Analysis Cross Section A-A'

Another approach to determine the failure mechanism is conducting a back analysis (Brown et al, 2016; Mandal et

al, 2017; Nejan and Timothy, 2008) by correcting the existing model to match the actual conditions at the time of failure. The cross-section incision map and Back Analysis are presented in (Fig. 6 and 7).
