RESEARCH ARTICLE

Slope Stability Analysis Throughout Road Around Bukit Barisan Selatan National Park (BBSNP) using Fellenius Method

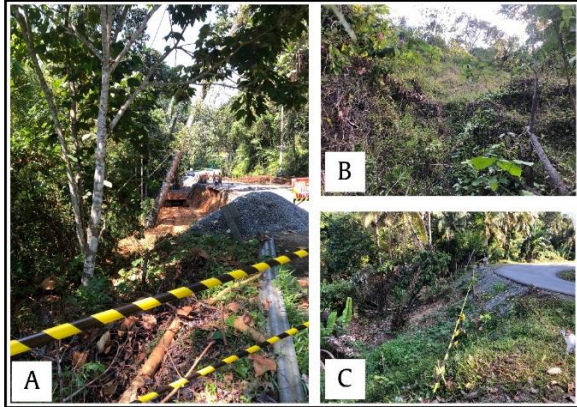
Fig 1. Several landslide alongside the cross-province road of BBSNP

Several slopes alongside the cross-province road of BBSNP have experienced landslides, disrupting the movement of vehicles and pedestrians along the road (Fig 1). Moreover, these landslides pose a safety hazard to residents in the area surrounding the cross-province road of BBSNP. Efforts are underway to reinforce these slopes to enhance road safety. The road reinforcement initiatives have been preceded by field mapping and engineering geological studies conducted by local and central governments. Our research aims to complement these field mapping and engineering geological studies, thereby providing valuable support to local authorities and

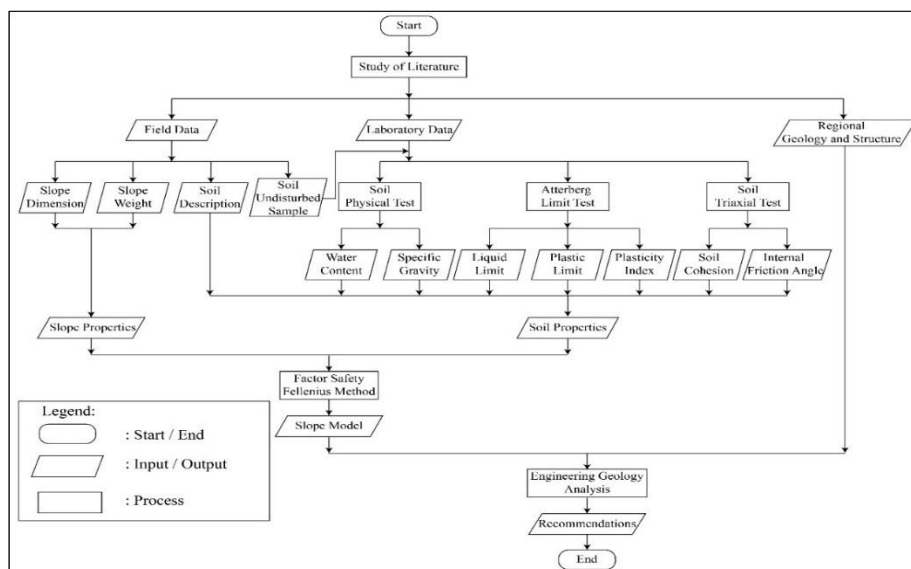
Fig 2. Research flowchart

In this study, the data utilized consists of geological and structure regional conditions, soil descriptions, soil physical and mechanical properties, water content, liquid limit, plastic limit, plasticity index, specific gravity, soil strength, slope dimensions, and slope weight (Fig 2).

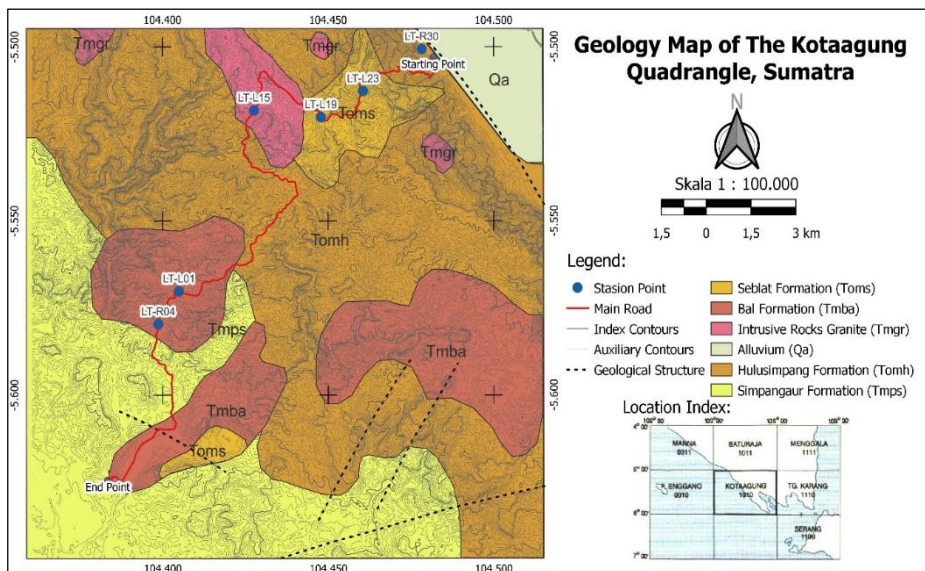
Fig 4. Geology of the Kotaagung Quadrangle, Sumatera

The regional geology of the research area along the road can be observed on the Geological Map of the Kota Agung Sheet, the Research Area (Amin et al., 1993) (Fig 4). Along this road, several formations are encountered, such as the Seblat Formation, Hulusimpang Formation, Bal Formation, and intrusive rocks.

The Seblat Formation (Toms) consists of interbedded mudstone, sandstone, tuffaceous sandstone, shale, limestone, marl, generally chalky, and thin-bedded or nodular limestone layers (Amin et al., 1993).

The Hulusimpang Formation (Tomh) comprises volcanic breccia, lava, andesitic-basaltic tuff, altered rocks, quartz veins, and sulfide minerals (Amin et al., 1993).

The Bal Formation (Tmba) consists of dacitic volcanic breccia, dacitic tuff, and sandstone intercalations (Amin et al., 1993). The intrusive rock (Tmgr) is in the form of granite (Amin et al., 1993).

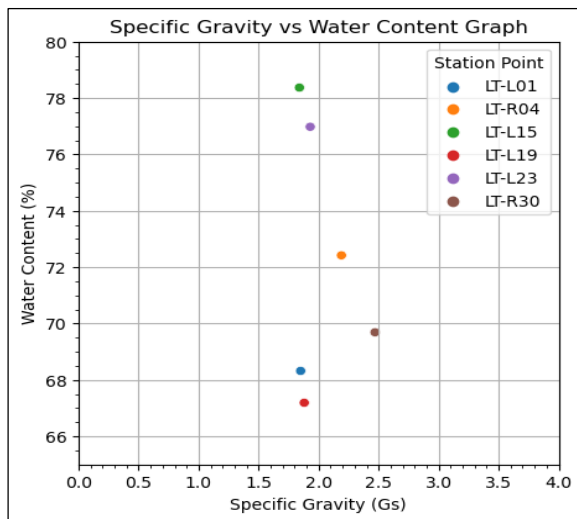
Fig 5. Specific gravity vs water content graph

The slope conditions are predominantly saturated with water, as indicated by the sufficiently high-water content above 67%. The potential for landslides is present in the slope conditions with saturated water. The saturated condition of water within slope materials can impose a load on the slope and enhance the driving force value. The mean water content in this research is 72.16%. Table 3 presents descriptive statistics for each station point and its parameters. Figure 5 shows a scatter plot between specific gravity and water content.

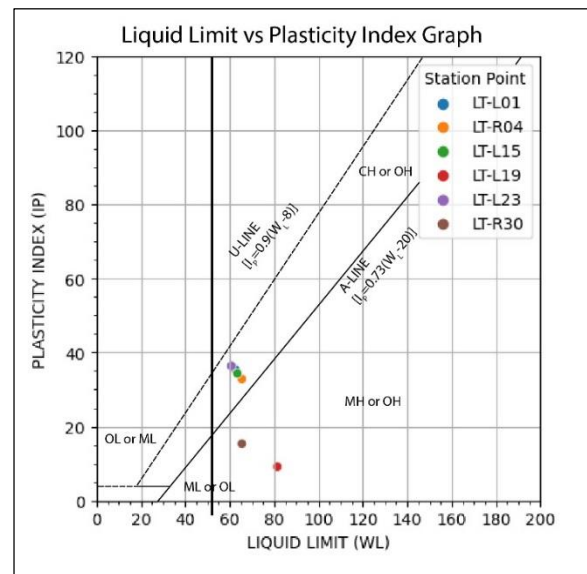
Fig 6. Liquid limit vs plasticity index graph

37% for each slope, indicating medium to high plasticity. The lowest plasticity index value, 9.17%, was found in slope LT-L19. The mean plasticity index in this research is 27.25%. The basic properties of slope LT-L19 material differ significantly from others, with high water saturation, low cohesive strength, and low plasticity conditions, indicating a potential risk of landslides in the future. Figure 6 shows a scatter plot between the liquid limit and the plasticity index.

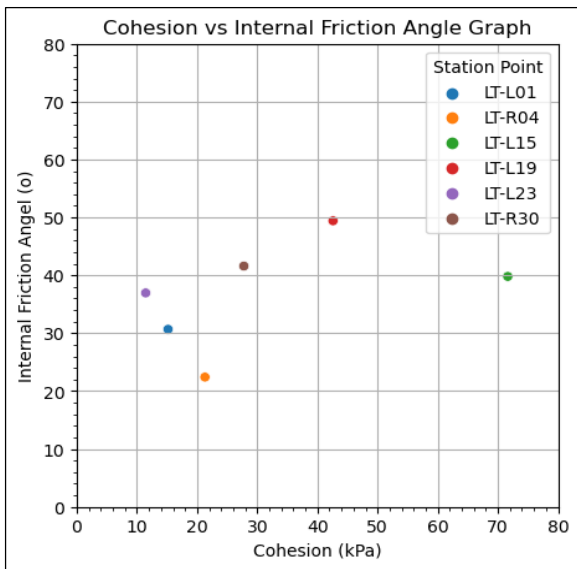
Fig 7. Cohesion vs internal friction angle graph

The internal friction angle, which measures the resistance of a soil to deformation or failure along a potential failure plane, is the angle between the horizontal and the inclined plane along which soil failure occurs. The data indicates a moderately varied internal friction angle, ranging from a low angle with a value of 22.42° to a high angle with a value of 49.42°, with a mean value of 36.81°. The internal friction angle influences the angle formed when a material becomes prone to failure and deforms. Subsequently, these effects impact the resultant forces on the internal properties of the soil material. Figure 7 shows

a scatter plot between cohesion and internal friction angle.

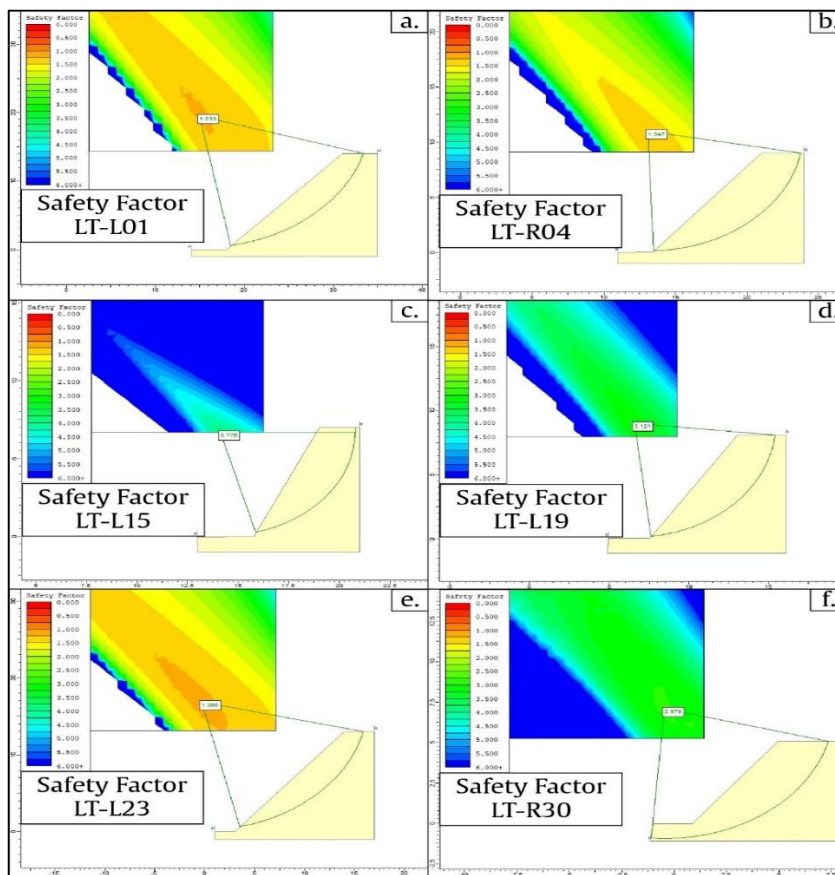
Fig 8. The slope safety factor model for each station points. a. Safety Factor LT-L01, b. Safety Factor LT-R04, c. Safety Factor LT-L15, d. Safety Factor LT-L19, e. Safety Factor LT-L23, f. Safety Factor LT-R30,

According to the data table, station point slopes can be classified into two categories: critical slope and stable slope. Critical slopes (LT-L01 and LT-L23) are situated in relatively tight contours, while stable slopes (the remaining slopes) tend to be in flat terrain or relatively open contours. The slope safety factor model for each station point is generated based on laboratory data (Fig. 8).

The critical slopes at LT-L01 and LT-L23 (Fig. 8a and 8e) exhibit nearly uniform soil properties, such as specific gravity below 2 Gs, water content saturated with water, and low cohesion classified as very soft, with an internal friction angle ranging from 30° to 40°. The plasticity properties are only slightly different from each other. Their lithology consists of inorganic clay of high plasticity. The critical safety factor is compromised due to the low cohesion values, making both slopes susceptible to landslides. There is a need for support and reinforcement, such as material compaction, to enhance cohesion values on the slopes. Additionally, there is a need to mitigate water saturation conditions in the slope materials.

The stable slopes (Fig. 8b, c, d, and f) exhibit variability across the slopes. Specific gravity values are below 2 Gs for slopes LT-L15 and LT-L19, while they are above 2 Gs for slopes LT-R04 and LT-R30. The water content, saturated with water, shows no significant difference among the slopes. Cohesion values for the slopes range from moderate to high, falling into the firm category. Internal friction angle values range from approximately 20° to 50°. Plasticity properties vary significantly from one slope to another. The lithology for slope LT-R04 consists of inorganic clay of high plasticity, slopes LT-L15 and LT-R30 share the lithology of silty clay of medium plasticity, while slope LT-L19 has lithology in the form of silty clay of low plasticity. The safety factor values indicate stability due to moderate to high cohesion, contributing to slope stability. Material compaction on the stable slopes is necessary to enhance cohesion values. Additionally, dewatering measures are required to reduce saturated conditions in the slope materials.
